Airtightness Measurement Before Rehabilitation

Reasons for measuring airtightness in existing buildings

Status analysis with thermography at negative pressure

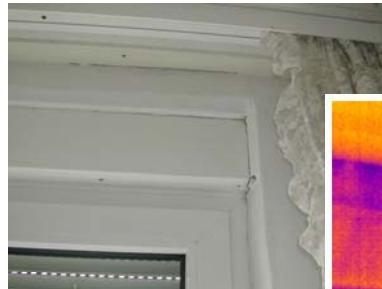
Roller shutter box

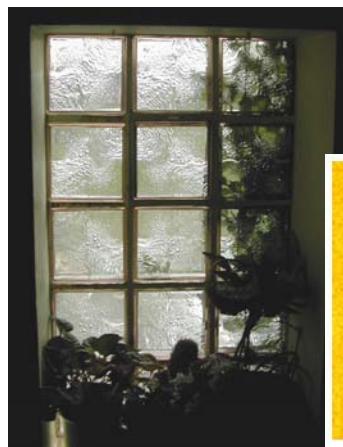
*Glass bricks,
one can be opened*

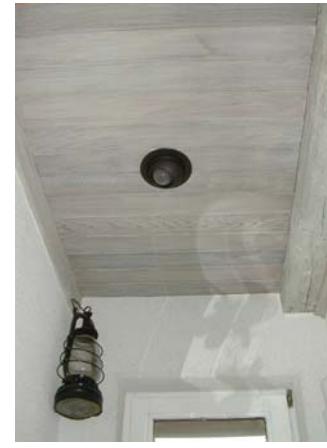
*Ceiling
connections*
